MARINE INVESTIGATION REPORT

M02W0089

CAPSIZING — TWO FATALITIES

LOG SALVAGE VESSEL *BRUCE BROWN*

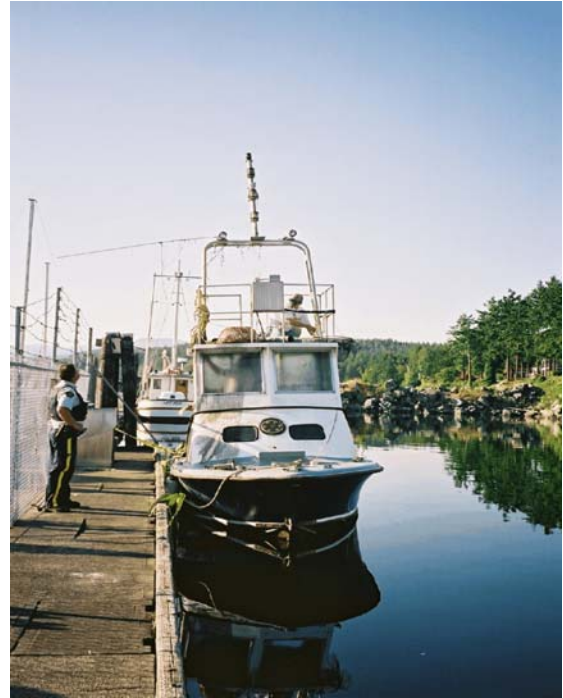
Photo 2. *Bruce Brown*, 2002. Note the addition of an enclosed wheelhouse, upper control station, and mast arch.

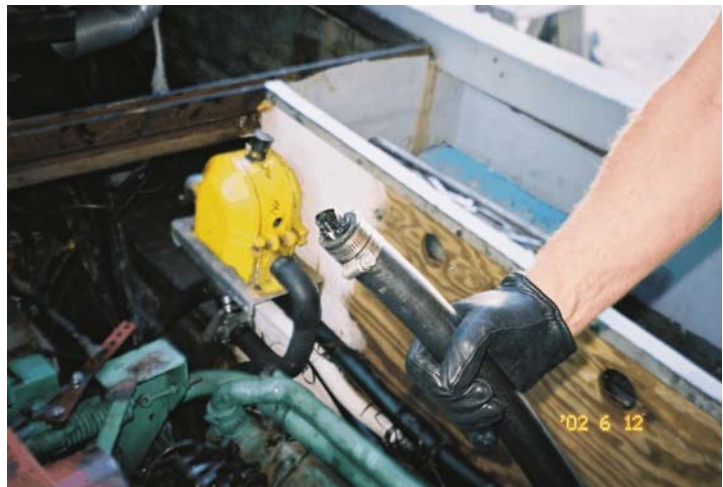
After the vessel was recovered, it was discovered that one of the two 28.5 mm, wire-reinforced rubber hoses on the discharge side of the raw water cooling system had parted. This failure was located in the section between the heat riser and the through-hull fitting at the side of the vessel, within the engine compartment. The hose parted where two lengths of hose of the same diameter had been joined with a metal connector. Examination of this connector revealed that, in place of a straight connector, a reducer had been used. One end of this reducer matched the 28.5 mm inside diameter of the rubber hose, while the other end was 25.4 mm in diameter. This smaller diameter had been built up to match the 28.5 mm inside diameter of the hose by the application of plastic electrician's tape. Two hose clamps had then been secured over each hose end at the reducer.

The raw cooling water, its temperature raised by heat drawn from the engine, warmed the electrician's tape and softened its adhesive. The wire reinforcing within the rubber hose limited the ability of the hose clamps to compress the hose against the reducer. The pressure of the cooling water, as supplied by the circulating pump, was sufficient to elongate the warmed adhesive of the electrician's tape until the connection failed and the hose parted (see Photo 3).

The engine's raw water circulation pump continued to supply cooling water to the system. Where the hose had parted, that water now flowed into the vessel's bilges instead of overboard. Because this hose failure occurred during darkness, it is unlikely that the operator would have been able to observe that the cooling water discharge was now reduced to a single stream. The accumulation of water in the bilges would have served to trim the vessel by the stern. A vessel's change of trim can often be detected when referenced to the horizon. This, however, would be more difficult to detect during darkness.

Photo 3. Electrician's tape protruding from failed joint in engine cooling hose

1. An improper hose connection on the discharge side of the engine's raw water cooling system failed. This failure allowed seawater, supplied by the engine's raw water pump, to quickly fill the vessel's bilges and engine compartment at the after end of the vessel.
2. The vessel's bilge pump was rigged for manual operation and was not fitted with a bilge high level alarm, either visual or audible, nor was this a mandatory requirement.
3. The vessel was not required to carry an emergency position indicating radio beacon (EPIRB), nor did it do so, and the rapidity of the capsizing precluded any broadcast of a VHF radio distress call to alert the authority.
4. The personal flotation devices used by the crew of the vessel did not provide adequate flotation and thermal protection capabilities. The vessel was not equipped with an inflatable liferaft, nor was it required to by regulations.

In August 2002, Transport Canada issued Ship Safety Bulletin No. 09/2002, *Bilge Pumping Systems: Early Detection Saves Lives*, to communicate to the industry the importance of bilge pumping systems and the early detection of any leakage into the hull compartments of any vessel.

Transport Canada is in the process of incorporating the *Construction Standards for Small Vessels* (TP 1332) as a Standard, by reference, into the *Small Vessel Regulations*. When this is done, the bilge high level alarm will become mandatory.
